Notice to Navigation Interests

Condition of Federal Navigation Channel Rocky River Harbor, Rocky River Ohio

ROCKY RIVER HARBOR, OHIO

CHANNEL CONDITIONS

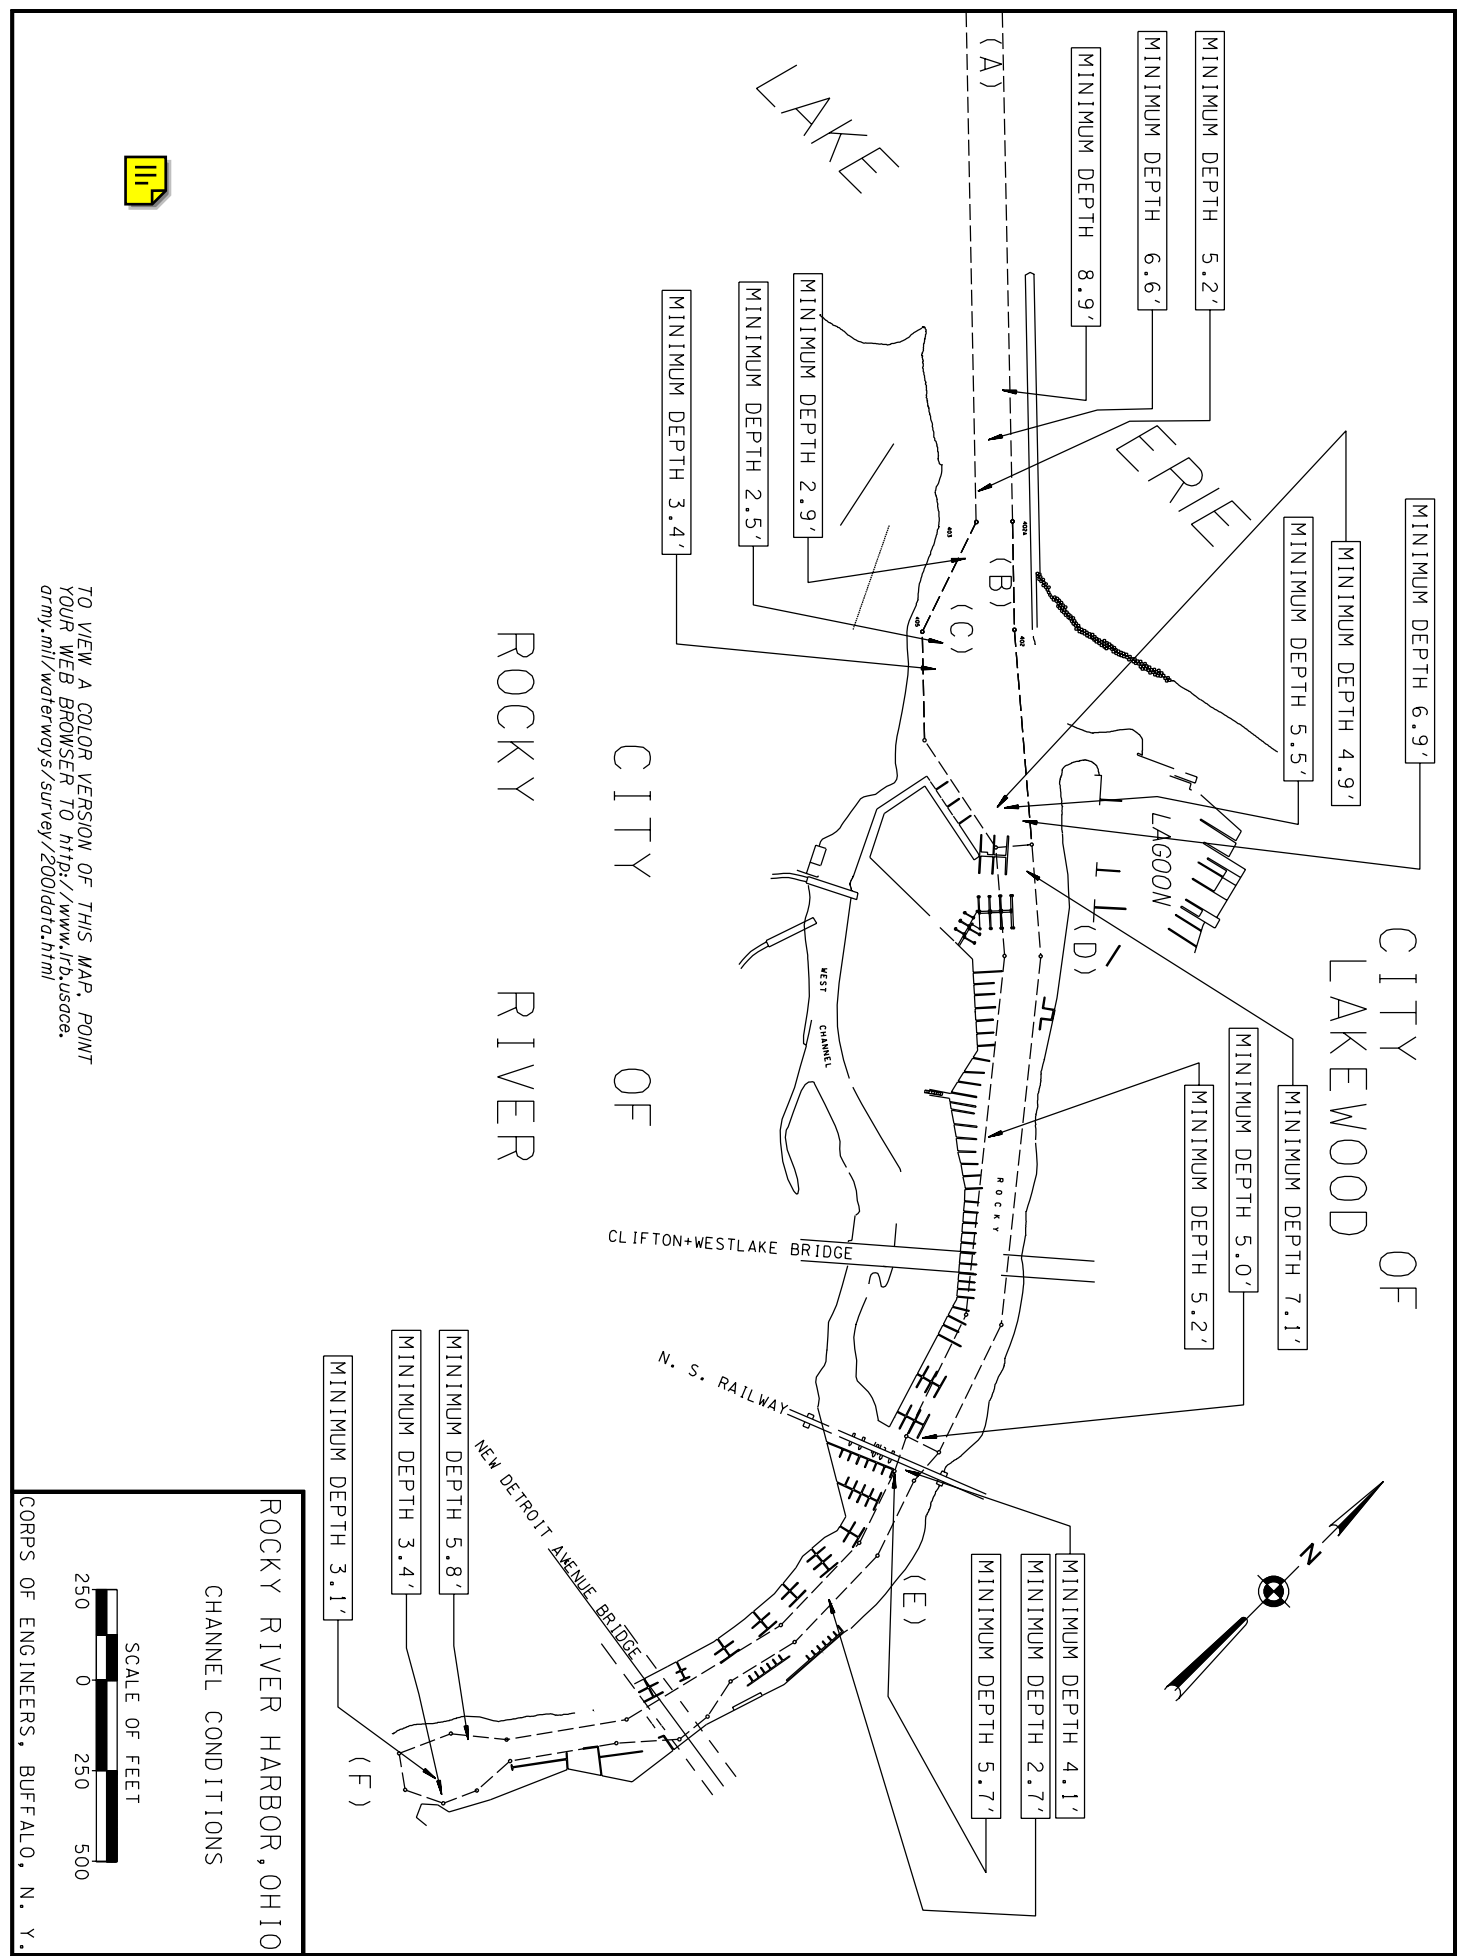
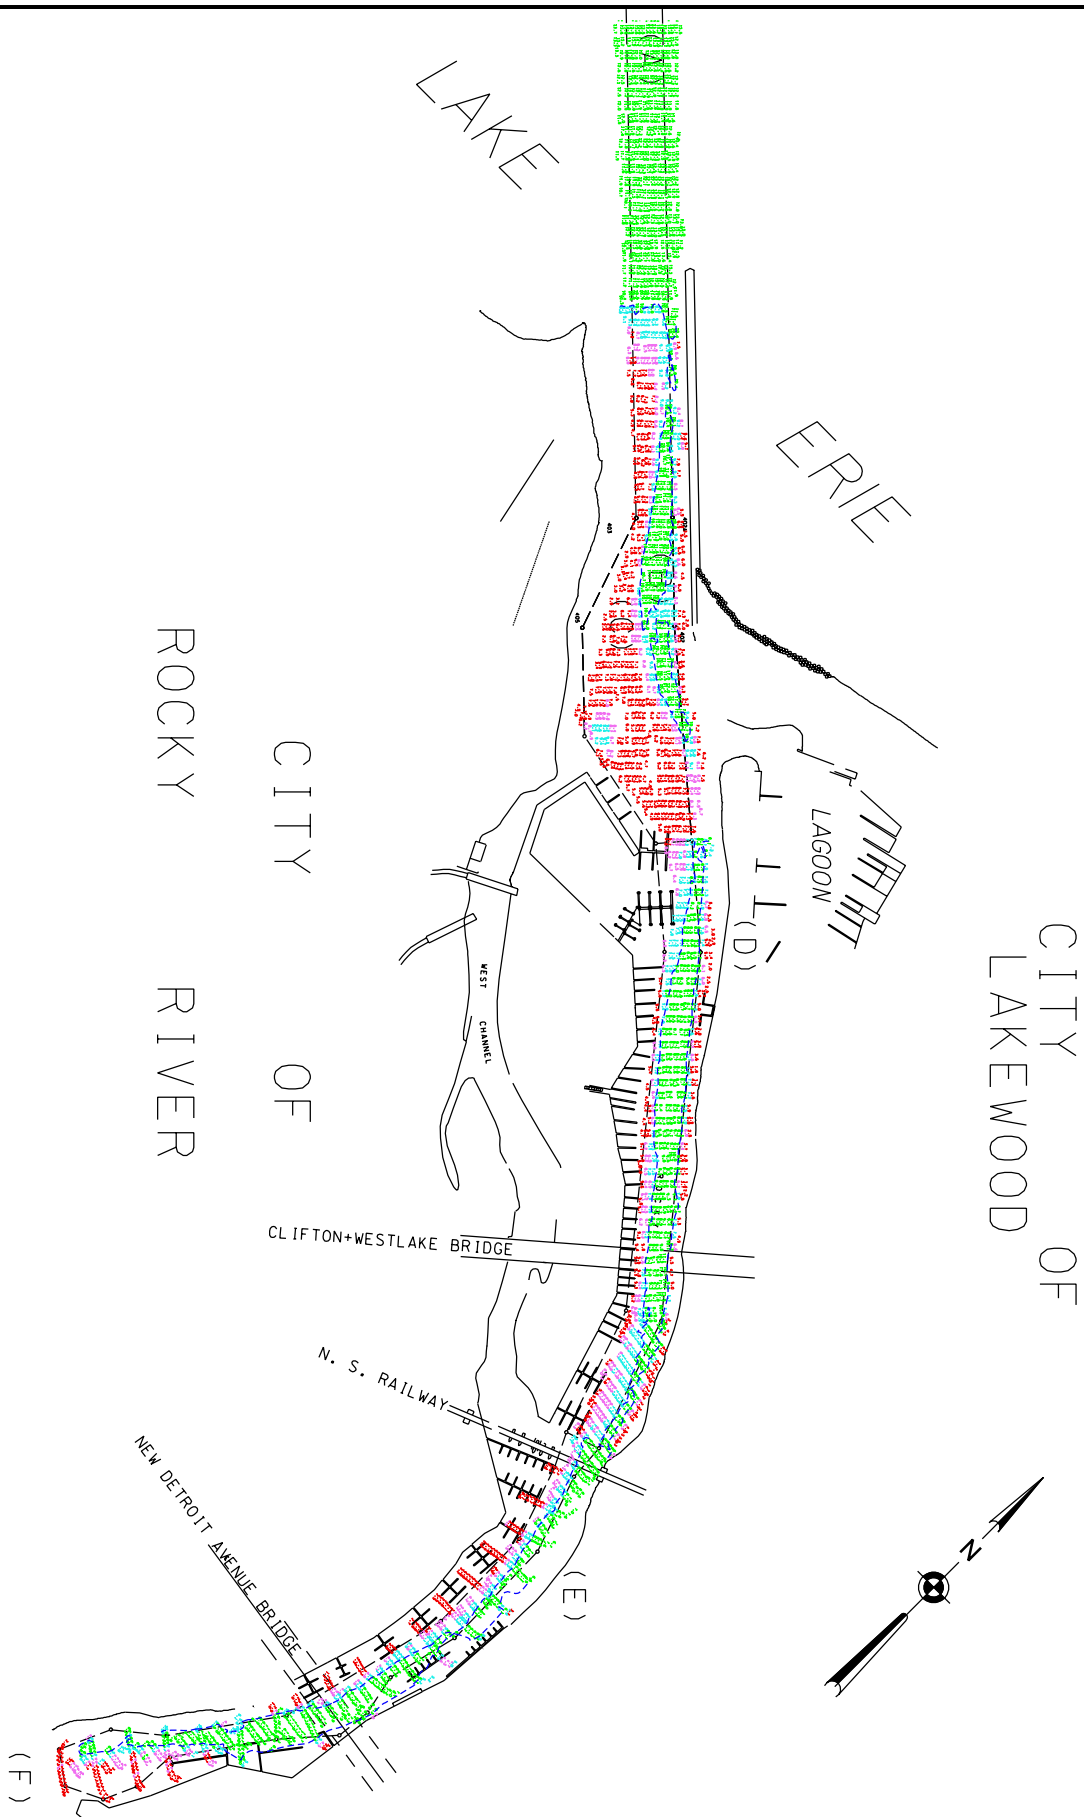
1. Condition surveys performed within the Federal navigation Channel at Rocky River, Ohio during the month of April 2002 indicate shoaling has reduced depths to those shown on the attached standard tabular form and channel condition drawing.

(A) ENTRANCE CHANNEL.	APRIL 2002	100	1400 (a)	10	8.9	6.6	5.2
(B) ROCKY RIVER CHANNEL FROM LOWER END OF THE ANCHORAGE AREA TO THE UPER END OF THE ANCHORAGE AREA.	APRIL 2002	100	900	10	6.9	5.5	4.9

(C) ANCHORAGE AREA.	APRIL 2002	175	900 (b)	10	2.9	2.5	3.4
(D) ROCKY RIVER CHANNEL FROM THE UPPER END OF THE ANCHORAGE AREA TO JUST DOWNSTREAM OF THE N.&W. RAILROAD BRIDGE.	APRIL 2002	100	1300	8	7.1	5.0	5.2

(E) ROCKY RIVER CHANNEL FROM JUST DOWNSTREAM OF THE N.&W. RAIL ROAD BRIDGE.	APRIL 2002	60-120	1550	6	2.7	4.1	5.7
(F) UPPER TURNING BASIN	APRIL 2002	180	300 (b)	6	3.4	3.1	5.8
REMARKS: (a) LENGTH VARIES DEPENDING ON THE LOCATION OF THE 10 FOOT CONTOUR IN LAKE ERIE. (b) IRREGULARLY SHAPED, SEE PROJECT CONDITION DRAWINGS.

3. Vessel operators are advised to use caution when navigating in this area.
4. Copies of the sounding print for Rocky River Ohio consisting of (1) sheet, 02S-RRH-1/1, at a cost of \$2.50 per sheet will be furnished upon receipt of a check in the full amount made payable to: United States Army Engineer District, Buffalo. Requests should be addressed to: District Commander, U.S. Army Engineer District, Buffalo, ATTN: NY/PA O&M Office, 1776 Niagara Street, Buffalo, New York 14207, requesting exact number or copies of sheets by file number. A point of contact and phone number must be indicated to facilitate response to the request. To obtain the Metadata and CADD files and view a color version of this map, point your web browser to **<http://www.lrb.usace.army.mil/waterways/survey/survey.html>** and locate the harbor on the table of harbors.
